ADVANCED COMPOSITE ELEVATOR FOR BOEING 727 AIRCRAFT VOLUME 2—FINAL REPORT

Boeing Commercial Airplane Company
P.O. Box 3707, Seattle, WA 98124

CONTRACT NAS1-14952
NOVEMBER 1980

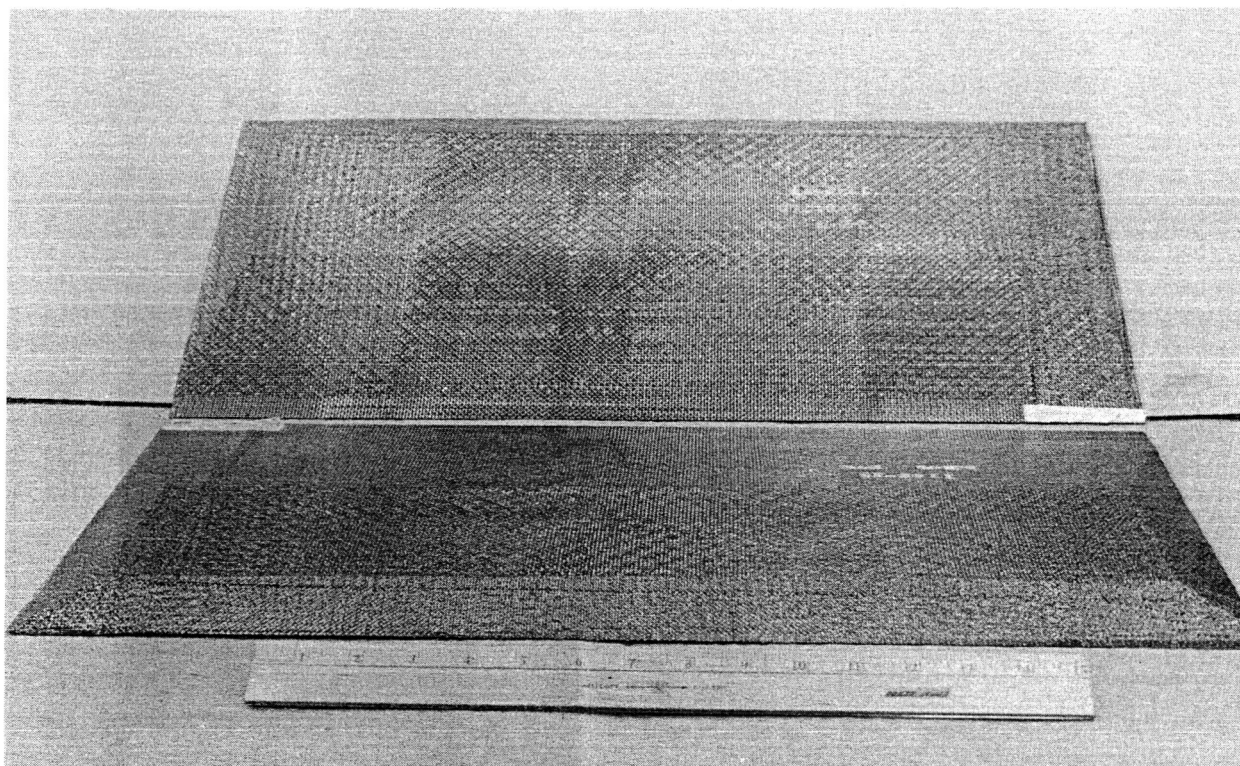
Figure 198. NDI Standard—Two Honeycomb Skin Panels

Skin Panel Standard—This standard has 0.64 x 0.64 cm (0.25 x 0.25 in), 1.27 x 1.27 cm (0.5 x 0.5 in), and 2.54 x 2.54 cm (1 x 1 in) defects. The standard was designed to duplicate upper and lower skin panels. See Figures 198 through 200.

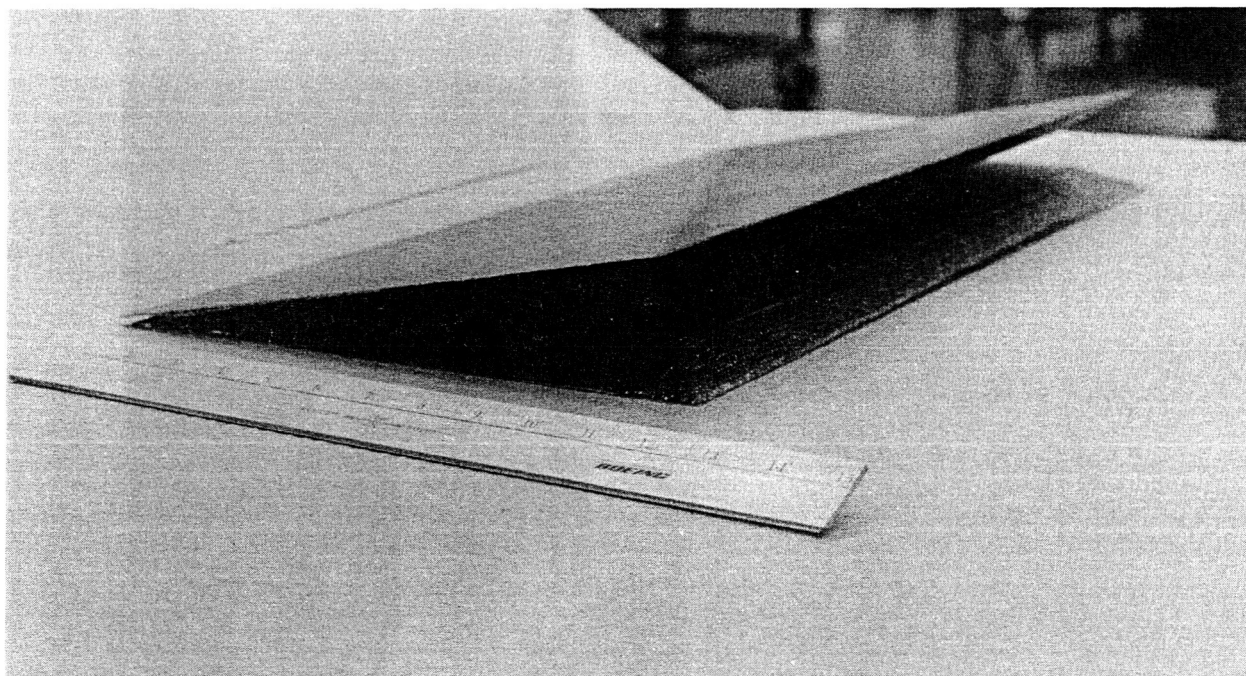
Figure 199. NDI Standard—Honeycomb Skin Panels Simulating Trailing-Edge Assembly

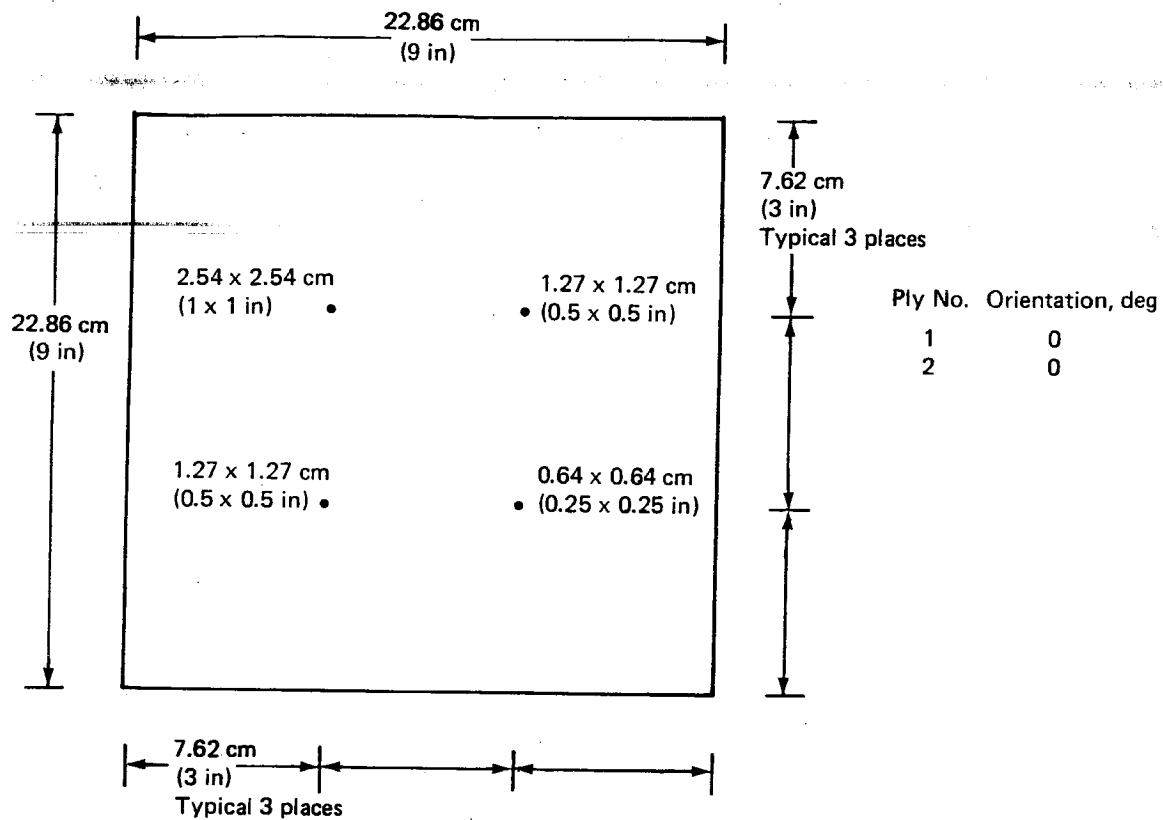
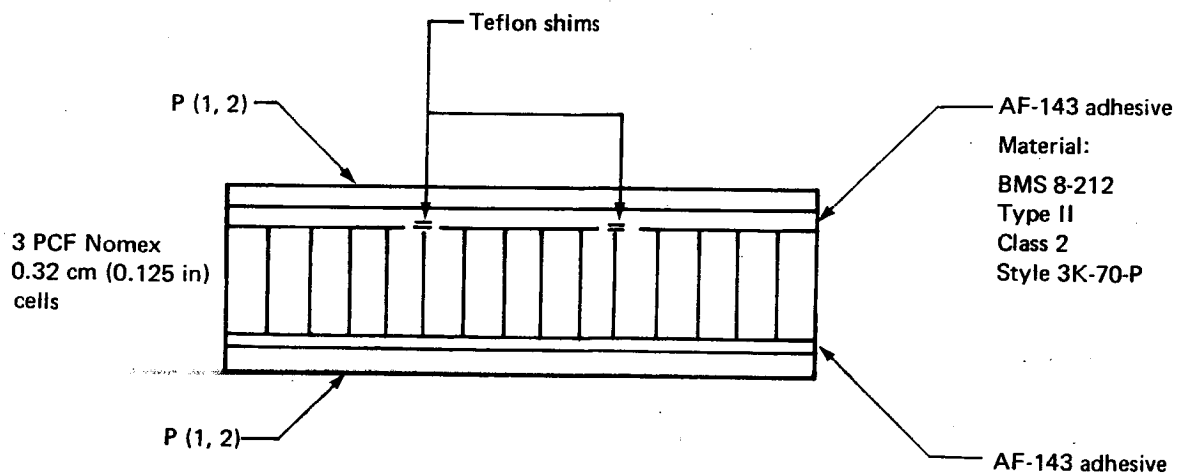
Figure 200. Skin Panel Standard

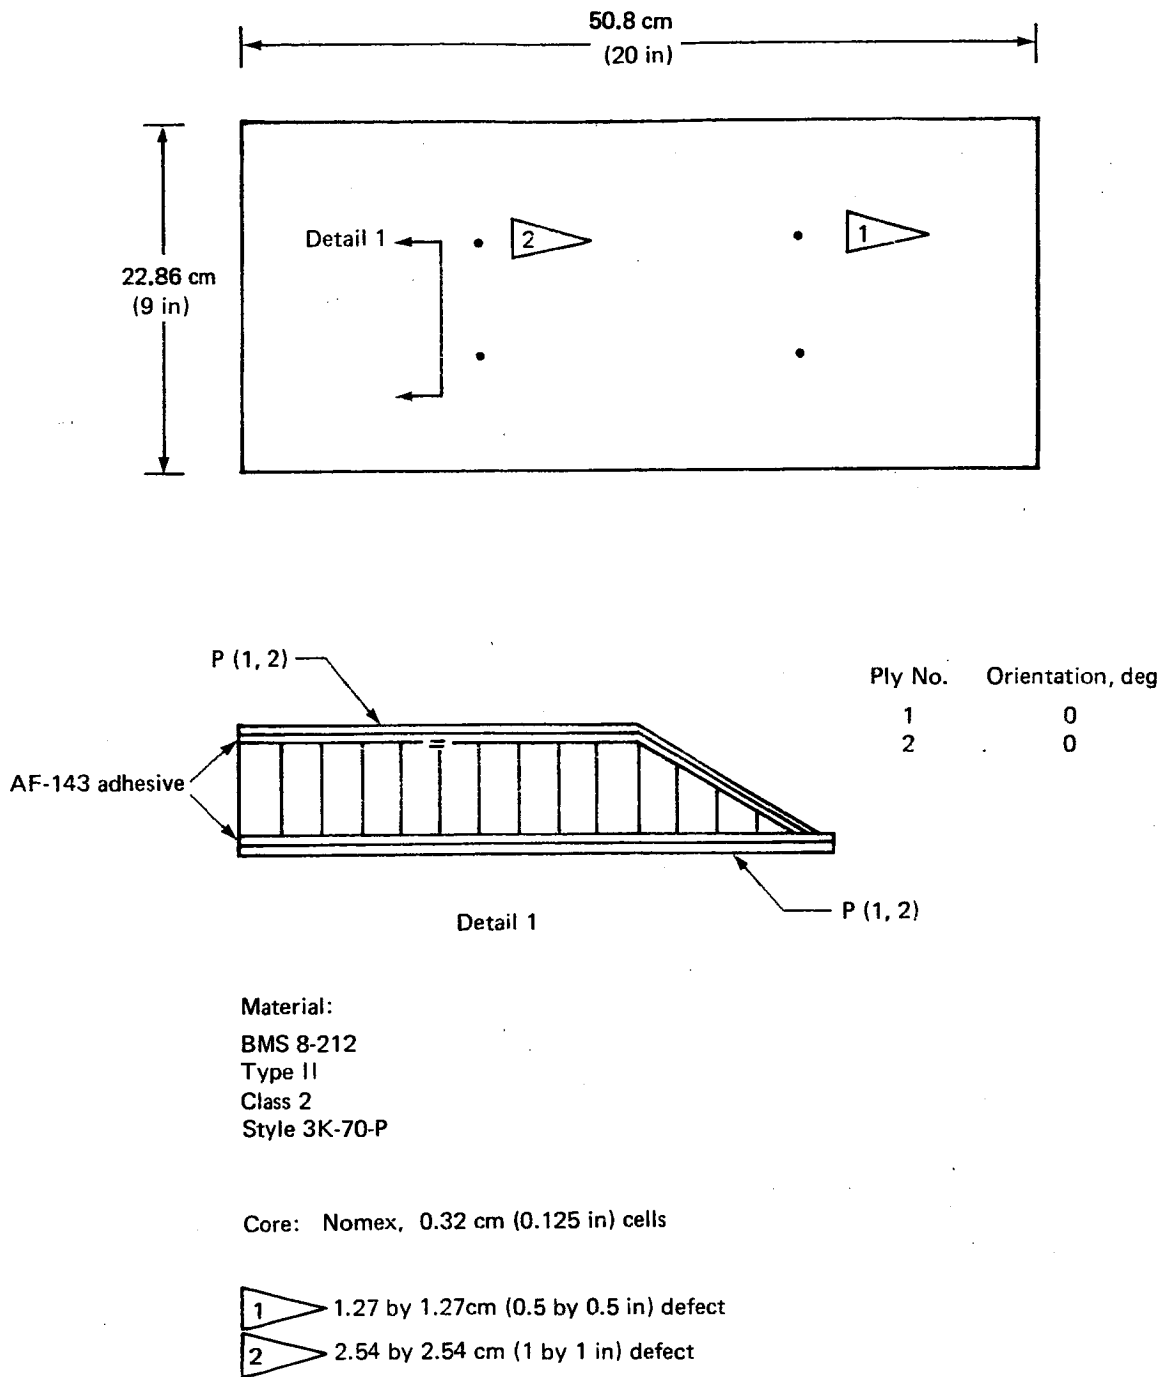
Figure 201. Taper Edge Standard

Taper Edge Standard—This standard was designed to investigate defects in the taper area of the skin panels. The defect sizes were in the taper area of the skin panels. The defect sizes were 1.27 x 1.27 cm (0.5 x 0.5 in) and 2.54 x 2.54 cm (1 x 1 in). See Figure 201.

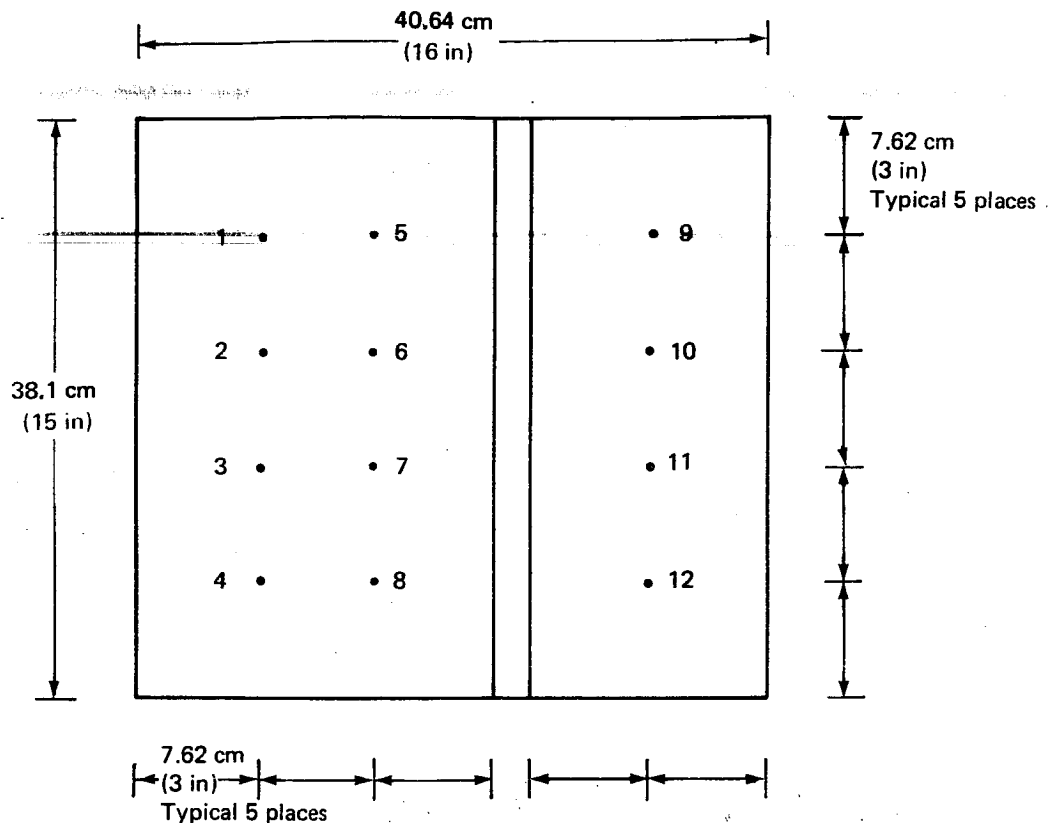
6 plies (fabric)
Material:
BMS 8-212
Type II
Class 2
Style 3K-70-P

All defects 1.27-by 1.27 cm (0.5 by 0.5 in) 2-mil Teflon shims

Defect No. 1 between P17 and P16
Defect No. 2 between P16 and P15
Defect No. 3 between P15 and P14
Defect No. 4 between P14 and P13
Defect No. 5 between P13 and P12
Defect No. 6 between P12 and P11

Defect No. 7 between P11 and P10
Defect No. 8 between P10 and P9
Defect No. 9 between P17 and P14
Defect No. 10 between P14 and P11
Defect No. 11 between P11 and P7
Defect No. 12 between P7 and P4

11 plies (tape)
Material:
BMS 8-212
Type II
Class 1
Grade 145

Figure 202. Front-Spar Chord Standard

Front Spar Chord Standard—This standard has 1.27 x 1.27 cm (0.5 x 0.5 in) defects in various thickness levels. See Figures 202 and 203.

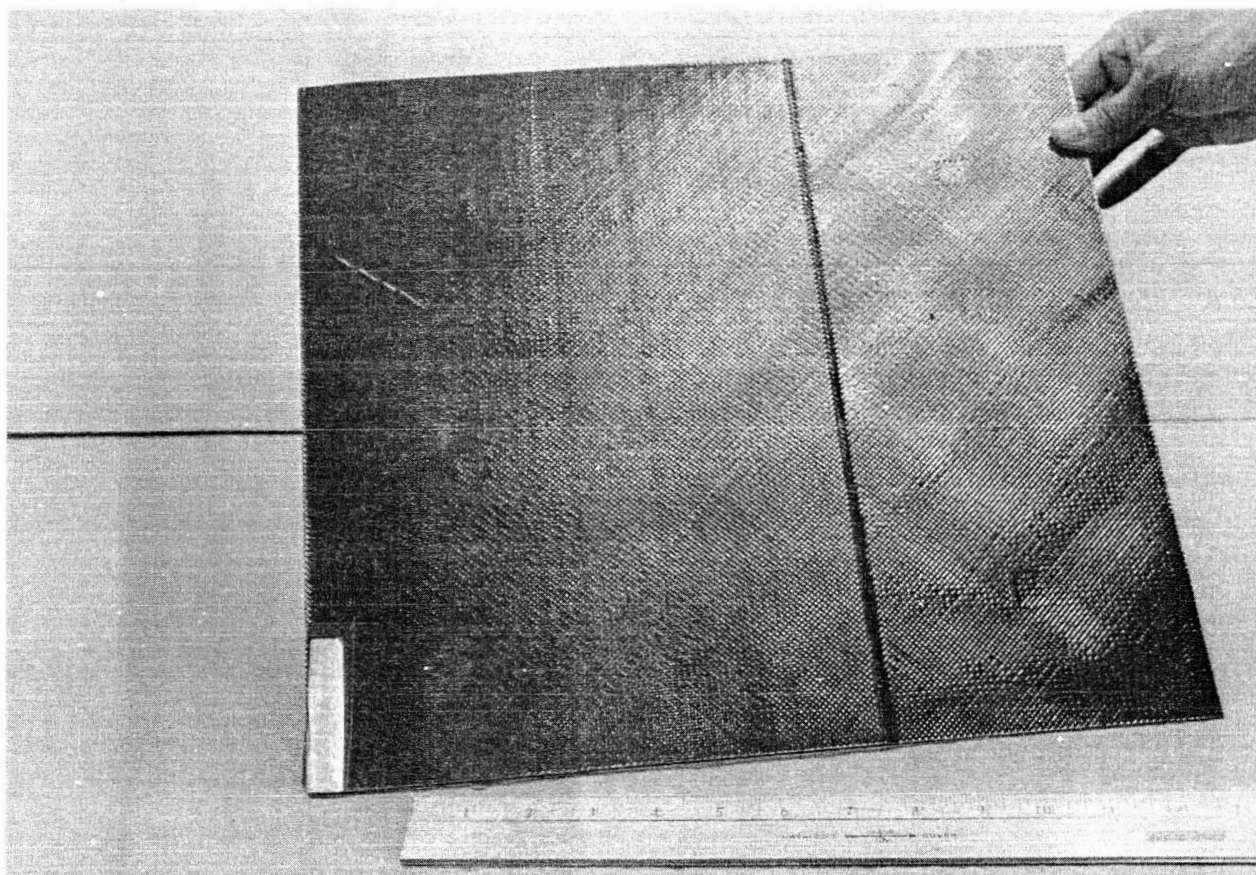
Figure 203. Preliminary NDI Standard—Front-Spar Chord

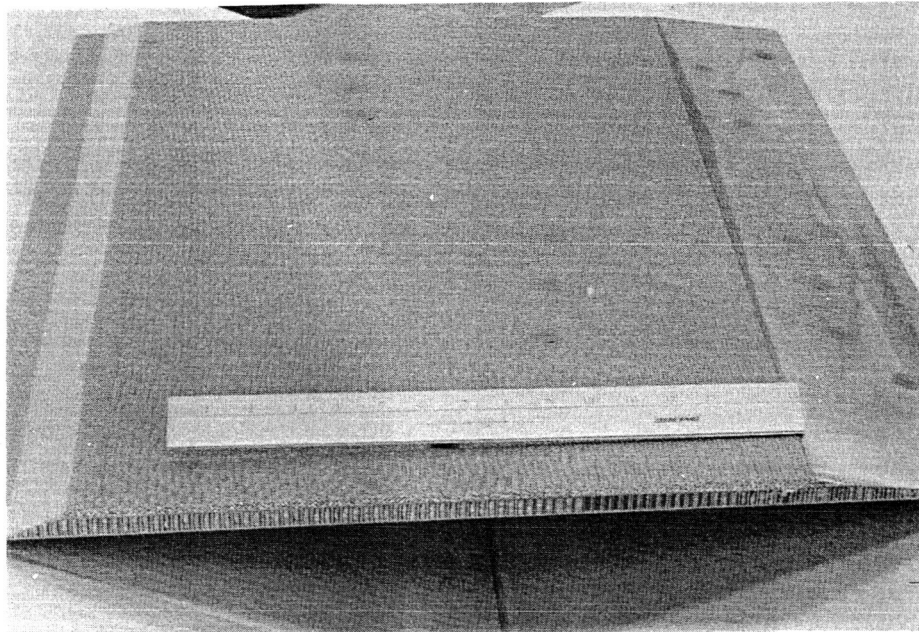
Figure 204. 727 Advanced Composite Elevator Skin-Panel Standard

- Upper and lower skin panel sections were fabricated per drawing 65C-17707-902 and 65C-17707-903 from station 136.50 to 173.21. The built-in defects, ranging from 0.64 x 0.64 cm (0.25 x 0.25 in) to 2.54 x 2.54 cm (1 x 1 in), were introduced throughout the panels, as shown in Figure 204.

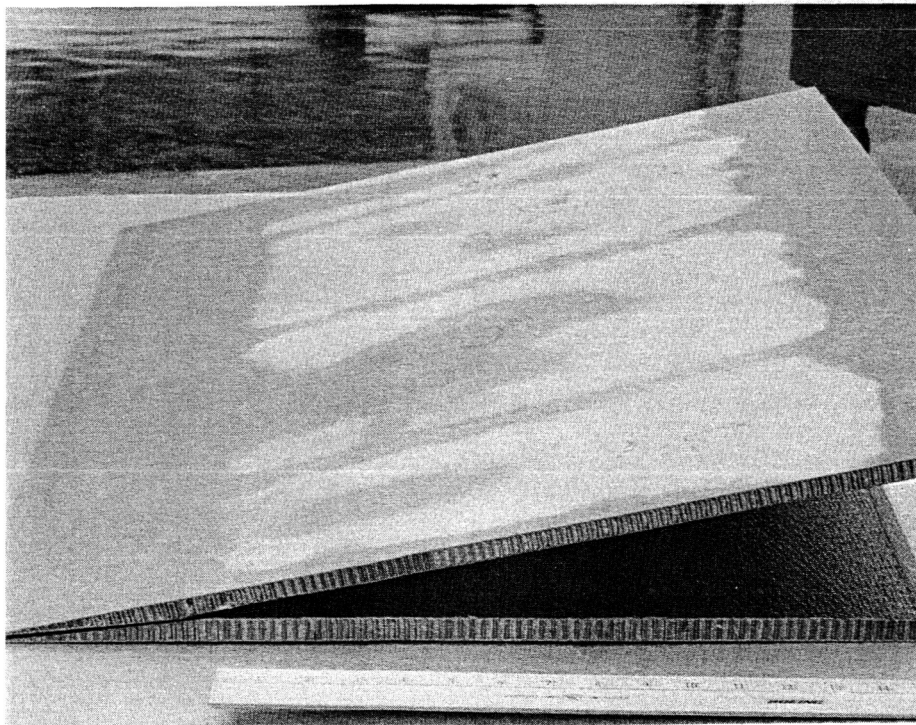
Figure 205. 727 Advanced Composite Elevator Trailing-Edge Assembly Standard

- The two additional skin panels were fabricated and then sealed at the tapered end to make a trailing-edge assembly. The incorporated defect size ranged from 1.27 x 1.27 cm (0.5 x 0.5 in) to 5.08 x 5.08 cm (2 x 2 in). The details are shown in Figure 205.

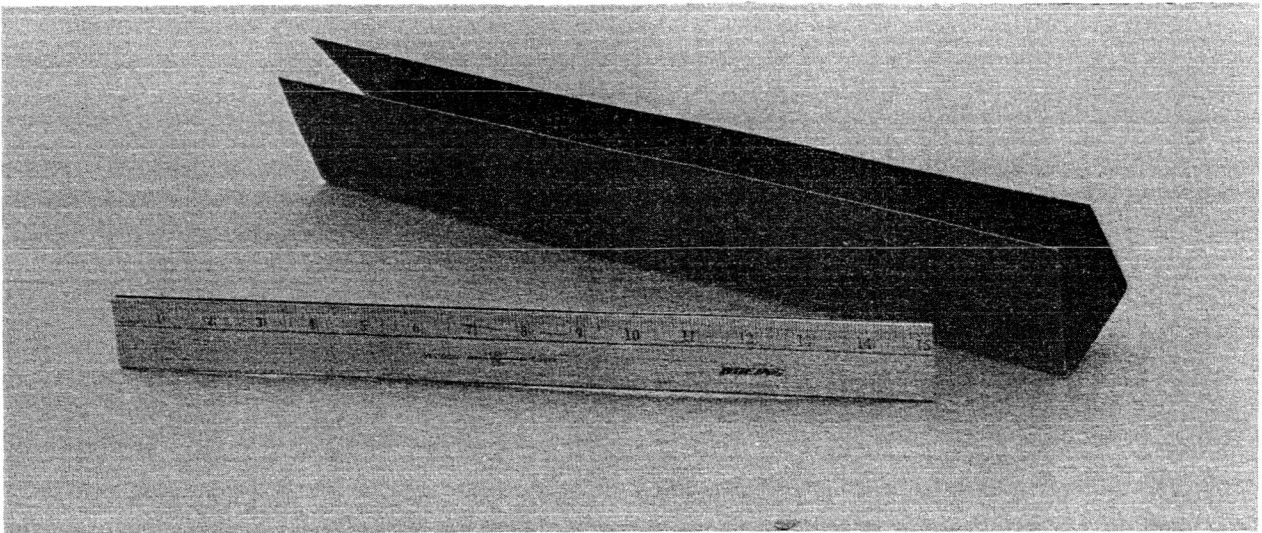
Figure 206. 727 Advanced Composite Elevator Rear-Spar Standard

- The rear spar standard, Figure 206, was built per drawing 65C-17707-9006E, from station 117.0 to 99.79. The defects ranged from 0.64 x 0.64 cm (0.25 x 0.25 in) to 2.54 x 2.54 cm (1 x 1 in).

All preliminary and production standards were evaluated using one or more of the above techniques. It was found that TTU was the most sensitive test method and the computerized C-scan capability provided a permanent record (fig. 206). Voids and delaminations are shown in darker areas of the scan. Semiportable and portable equipment and techniques were used without C-scan capability, but having a light meter and audible defect indicators (figs. 207 and 208). TTU C-scan inspection was capable of reliable defect detection to 0.64 x 0.64 cm (0.25 x 0.25 in). Using portable and semiportable TTU with manual scanning, the detection capability was limited to defects 1.27 x 1.27 cm (0.5 x 0.5 in). The latter techniques were used in rib sections, flange, and spar areas (fig. 209).

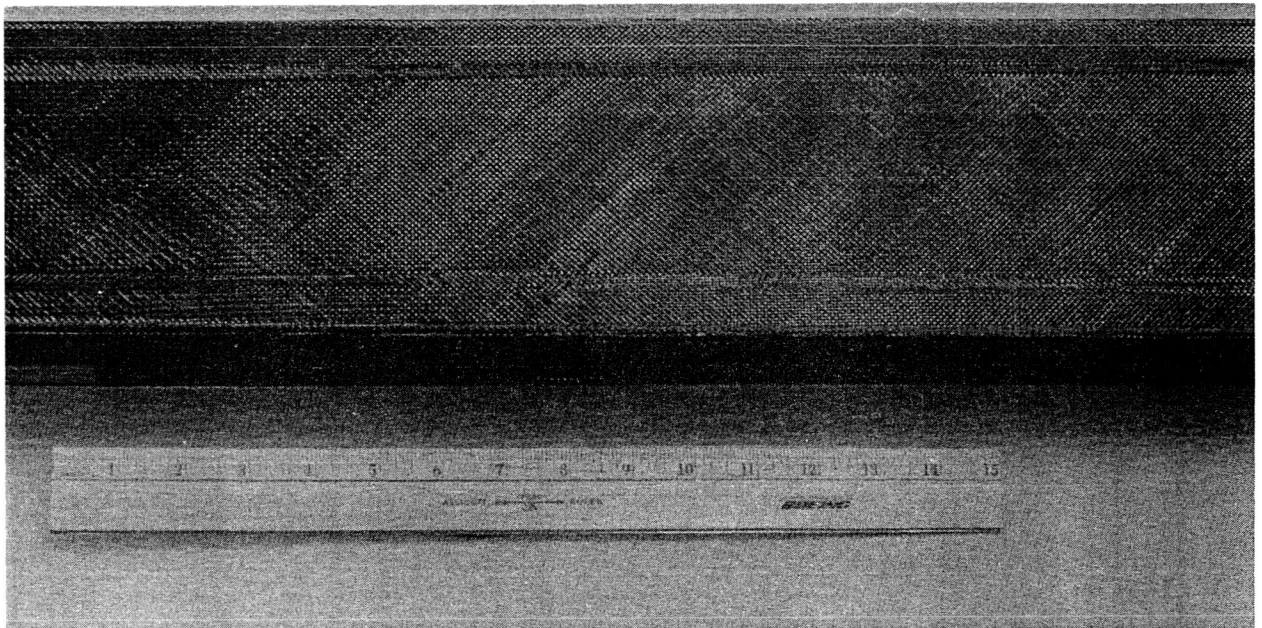
Figure 207. 727 Advanced Composite Elevator Front-Spar Standard

- The front spar standard, Figure 207, was built per drawing 65C-17707-9006E, from station 149.34 to 129.19, with defects ranging from 0.64 x 0.64 cm (0.25 x 0.25 in) to 2.54 x 2.54 cm (1 x 1 in).

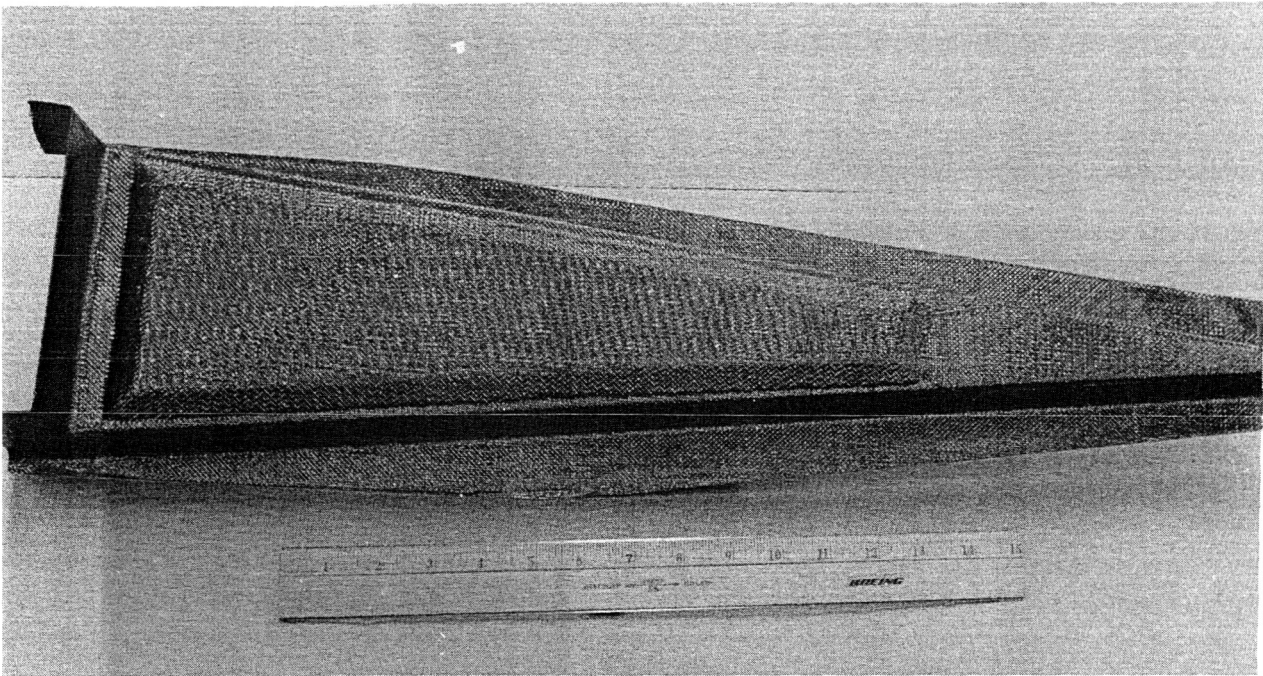
Figure 208. 727 Advanced Composite Elevator Rib Standard

- The rib standard, Figure 208, was built per drawing 65C-17707-4E, full size. The defects ranged from 0.64 x 0.64 cm (0.25 x 0.25 in) to 2.54 x 2.54 cm (1 x 1 in).

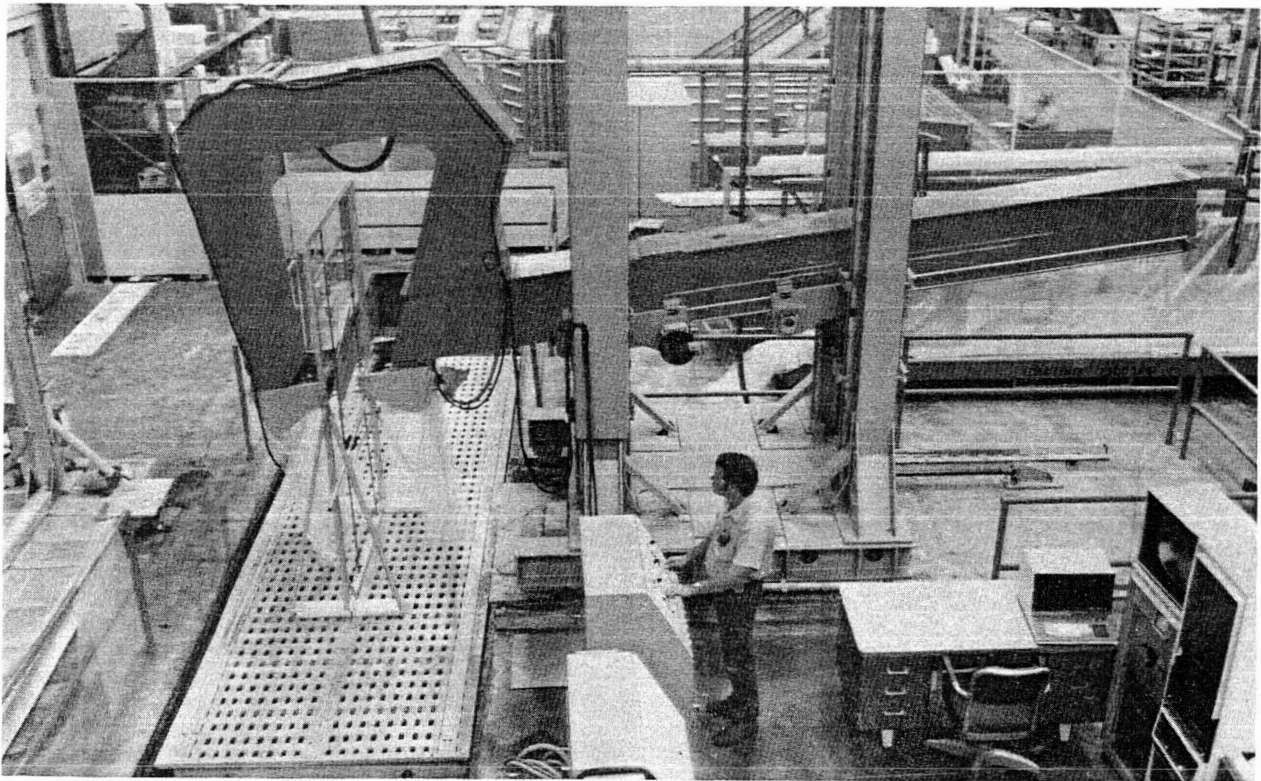
Figure 209. Automated TTU Scanner

- Through-Transmission Ultrasonic (TTU) with automated scanning and computerized C-scan recording and/or a visual display (figs. 209 and 210)
- Portable and semi-portable TTU, manual scanning with light meter and audible defect indication (figs. 211 and 212)
- Sondicator, Models -1 or S-2B; manual ultrasonic inspection (fig. 213)
- Fokker Bond Tester (fig. 214)
- Radiographic inspection, low-kilovoltage (15--40 kV)

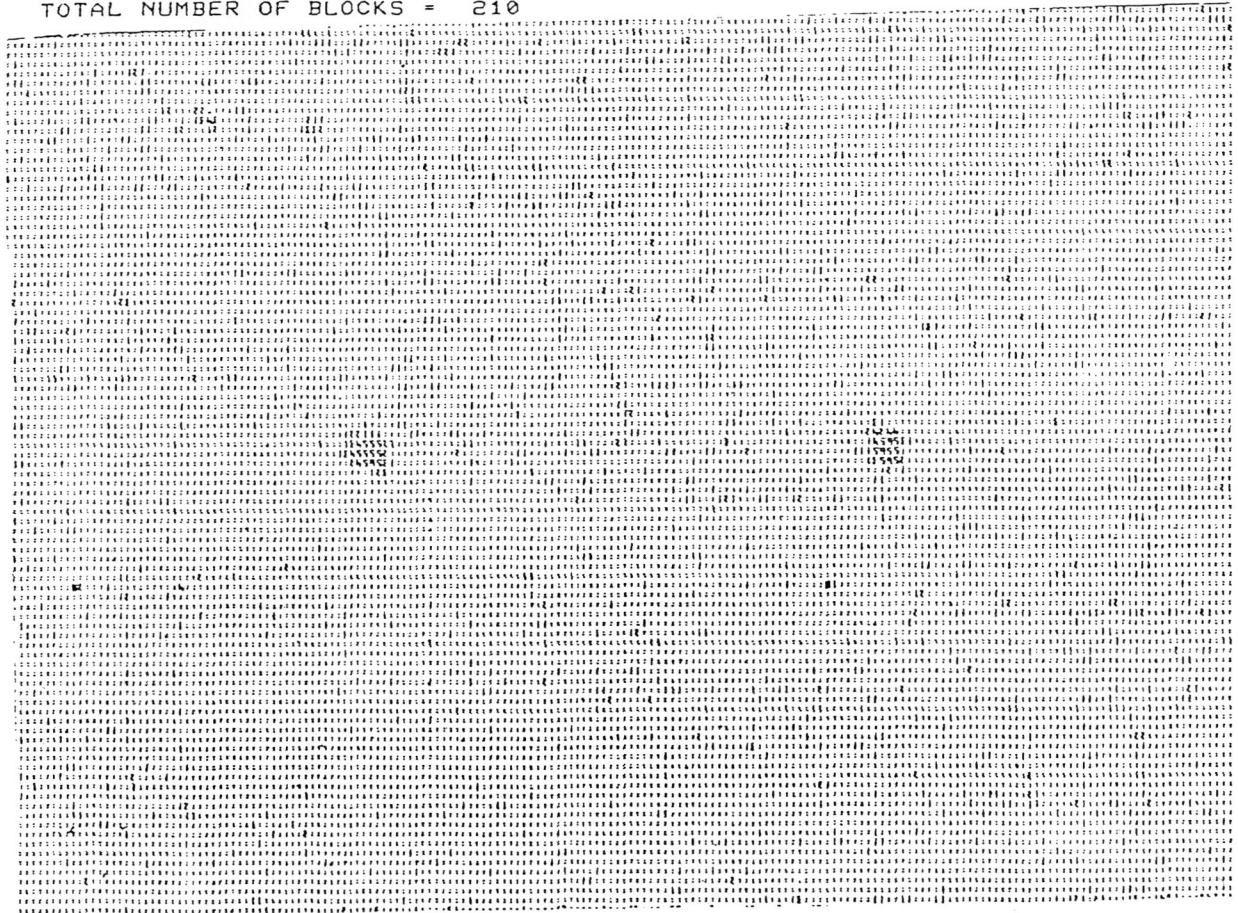
GRAPHITE TEST PANEL
 PART NUMBER = 11423A
 DATE = 3/9/78
 SCANNER INDEX = 60 THOUSANDTHS
 X SCALE = 1 Y SCALE = 1
 PLOTTING SEQUENCE = 1,0,0,0,0,0.

TOTAL NUMBER OF BLOCKS = 210

Figure 210 Graphite-Epoxy Test Panel Standard, Computerized C-Scan Recording

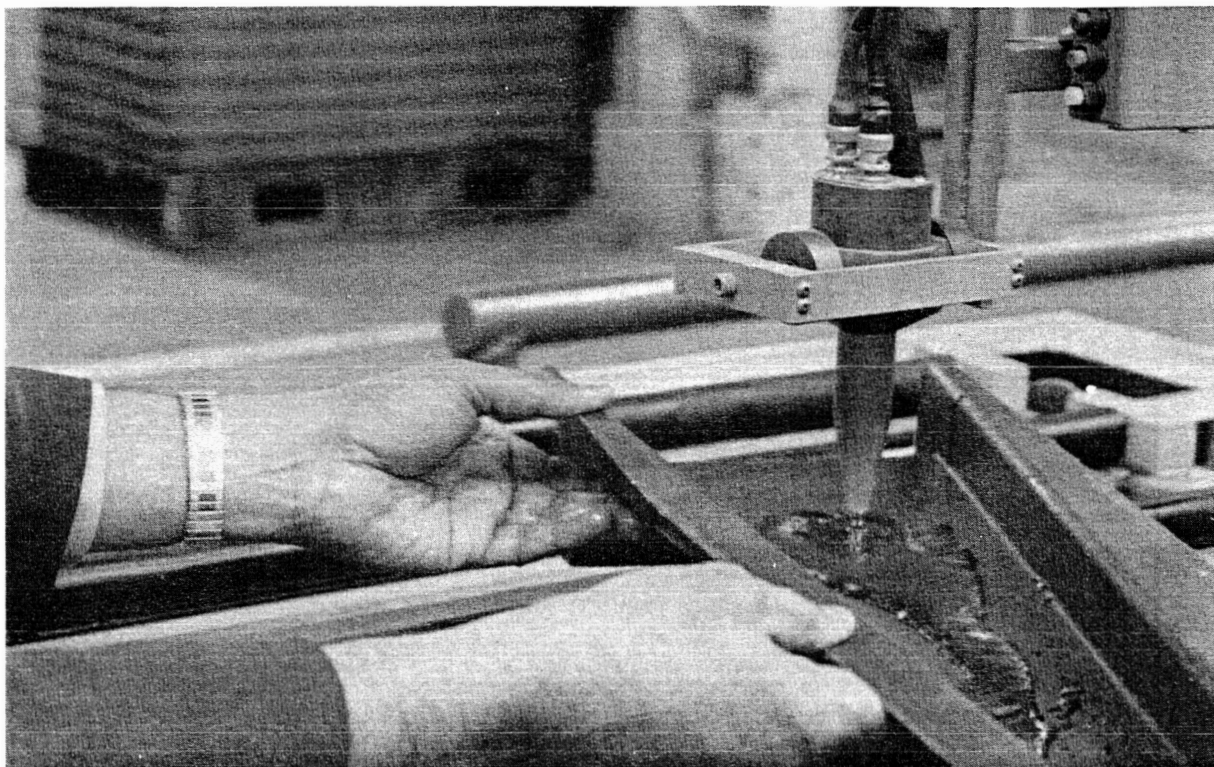
Figure 211. Semiportable TTU Scanner without C-Scan Capability

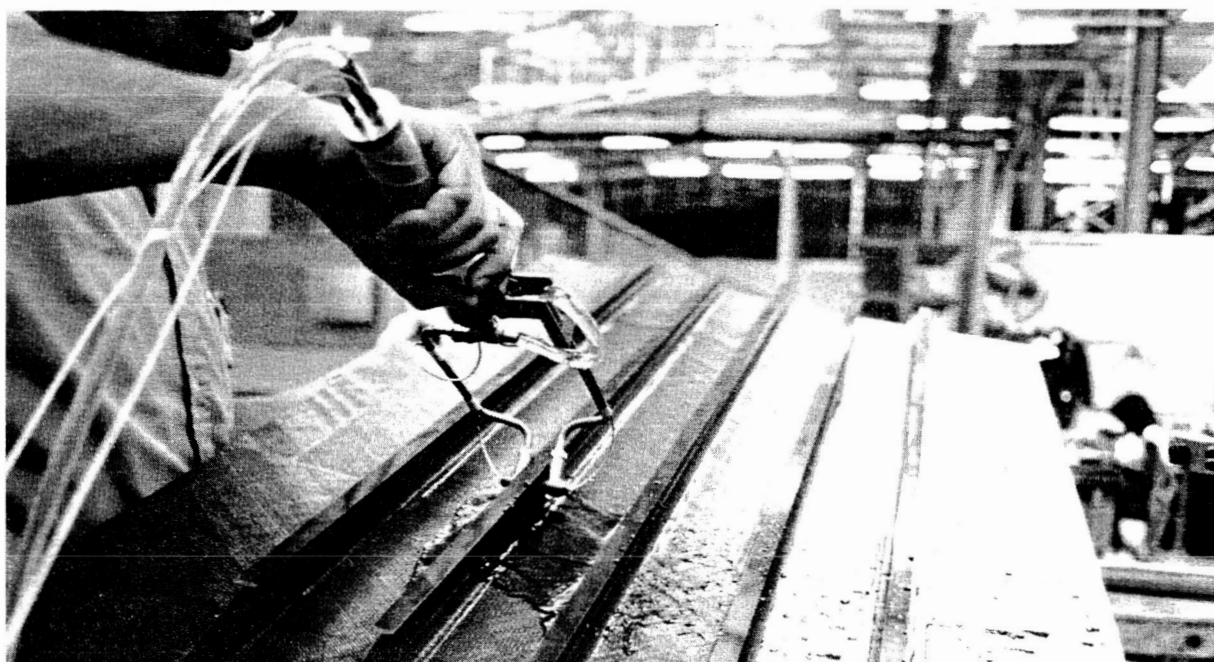
Figure 212. Portable TTU Scanner, Showing Inspection of Flange Area by Hand-Held TTU Unit

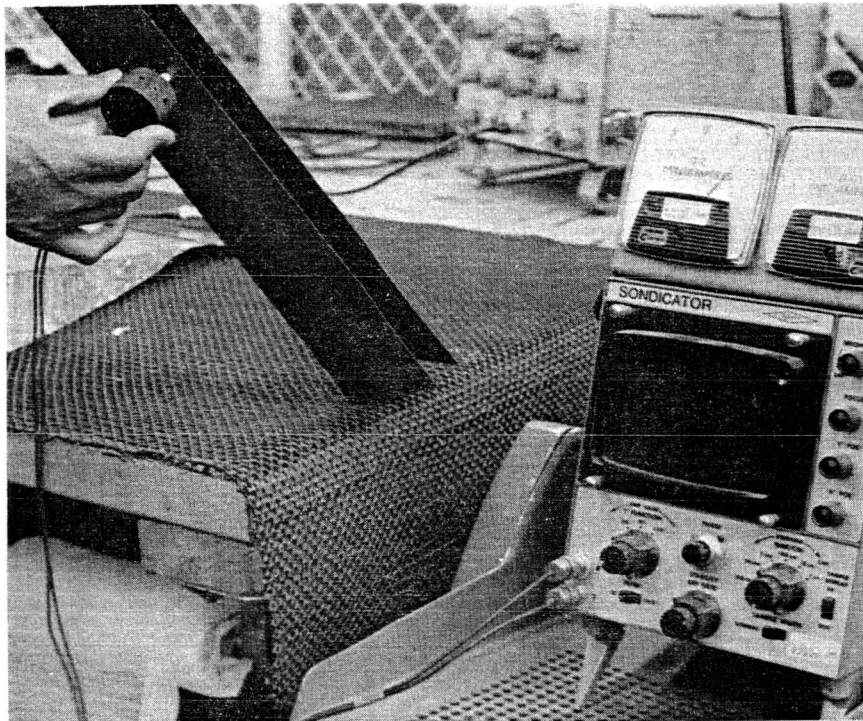
Figure 213. Sondicator Inspection of Configuration Not Suitable for TTU Scan

The Sondicator and Fokker Bond Tester also were used for defect detection in those areas where manual scanning was required. Both were effective down to a detection limit of 1.27 x 1.27 cm (0.5 x 0.5 in). In the sealed area of the trailing edge, radiographic inspection was determined to be the only suitable technique for detecting minute voids in the sealant. In-service and maintenance inspection can be performed using the Sondicator, Bond Tester, and/or X-ray (when practical). Under these conditions (outside the laboratory or production environment), the realistic defect detection capability is expected to be 2.54 x 2.54 cm (1.0 x 1.0 in) or larger.

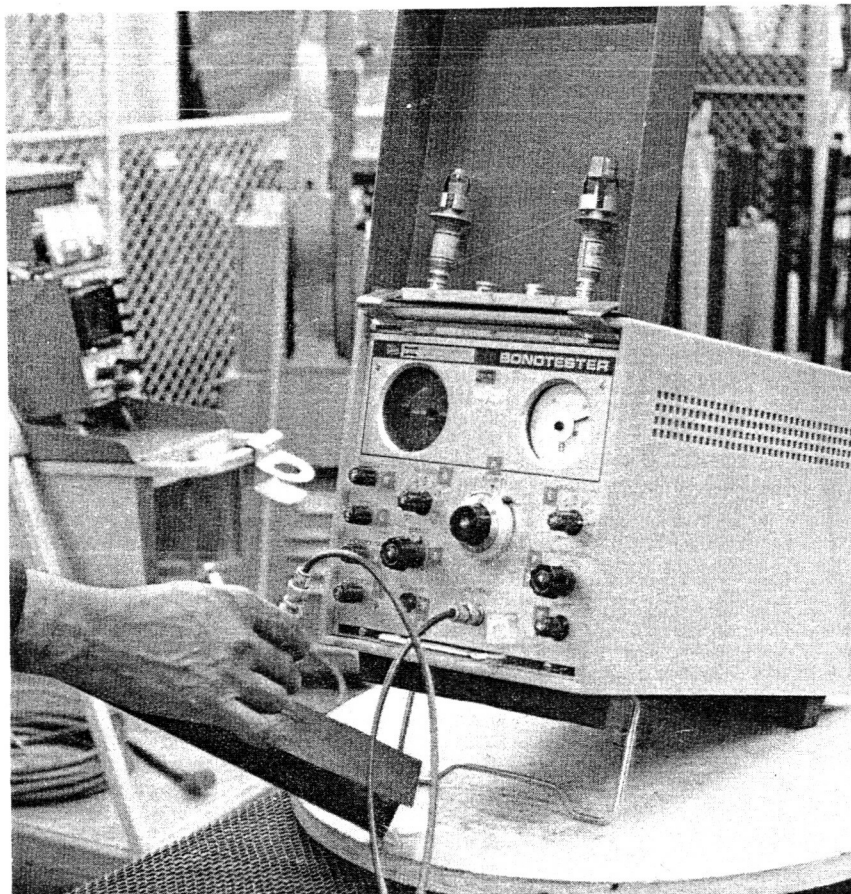
Figure 214. Fokker Bond Testing of Configuration Not Suitable TTU Scan

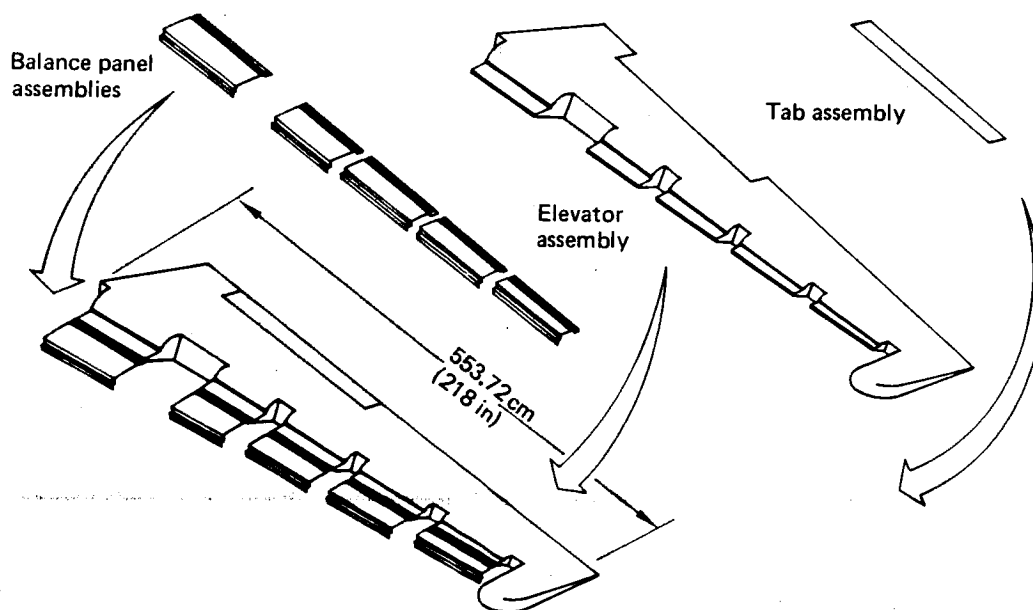
Figure 215. Elevator/Tab/Balance Panel Assembly

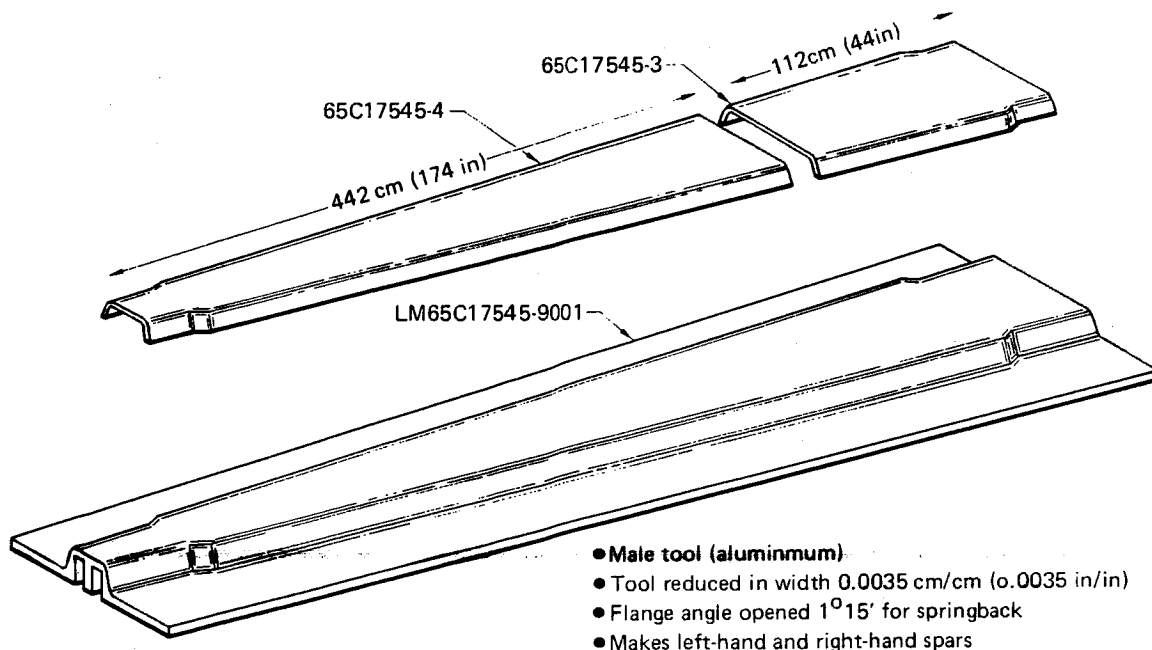
Figure 216. Front Spar and Layup Mandrel

Layup Mandrel--A tool used to lay up inboard and outboard sections of spar (figs. 216 and 217).

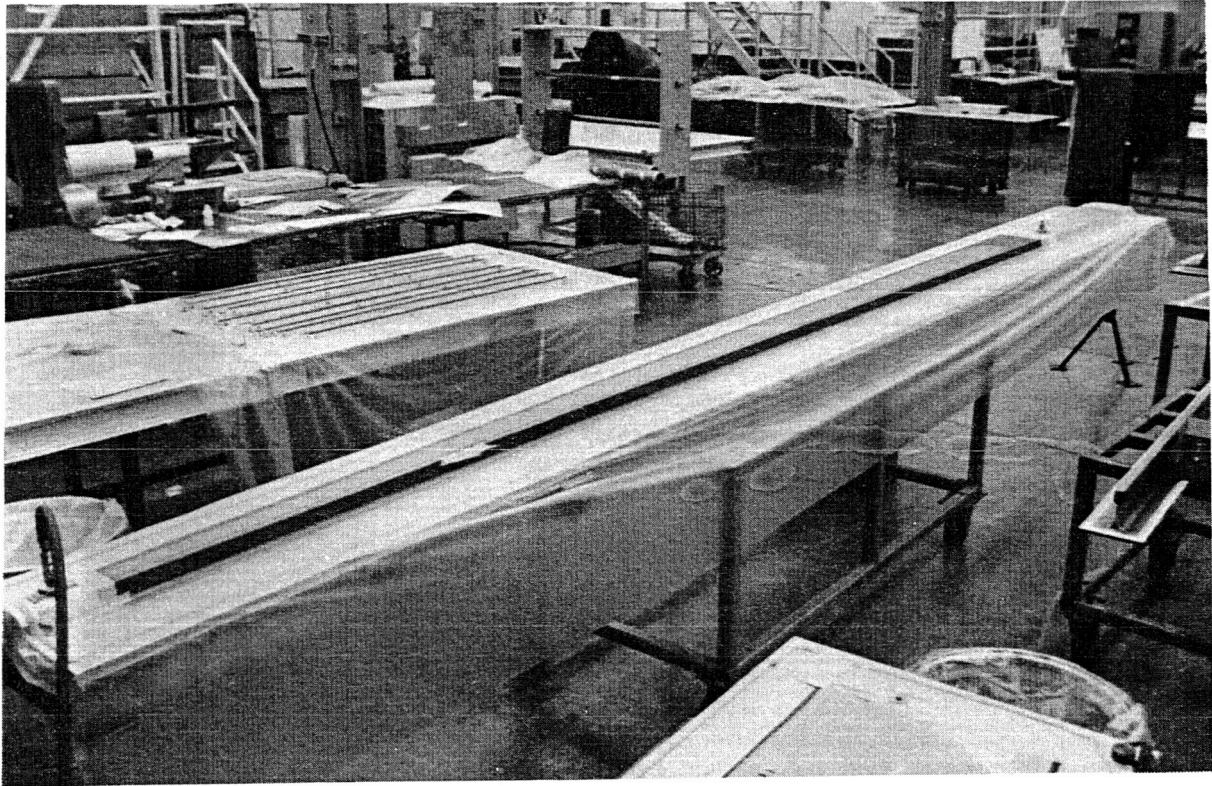
Figure 217. Front-Spar Assembly Tool with Outboard Spar Detail

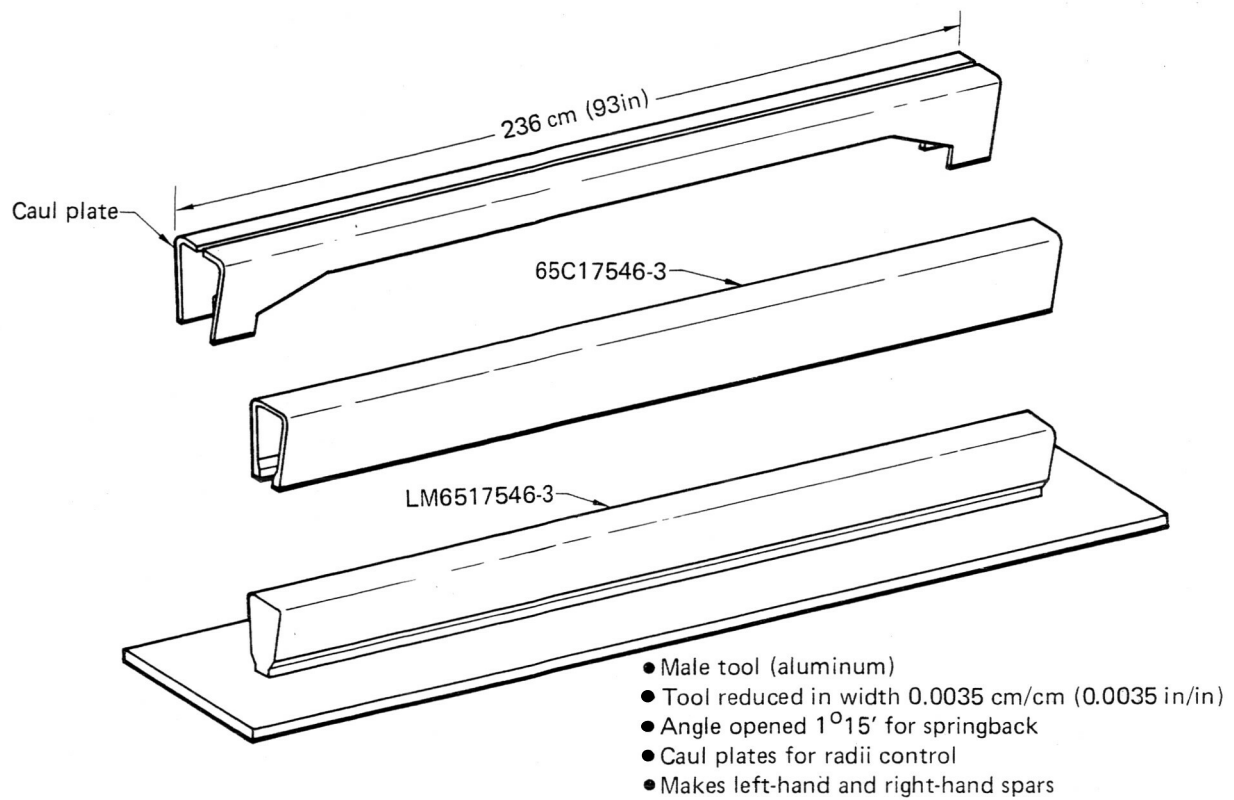
Figure 218. Rear Spar and Layup Mandrel

Layup Mandrel--This tool is shown in Figures 218 and 219.

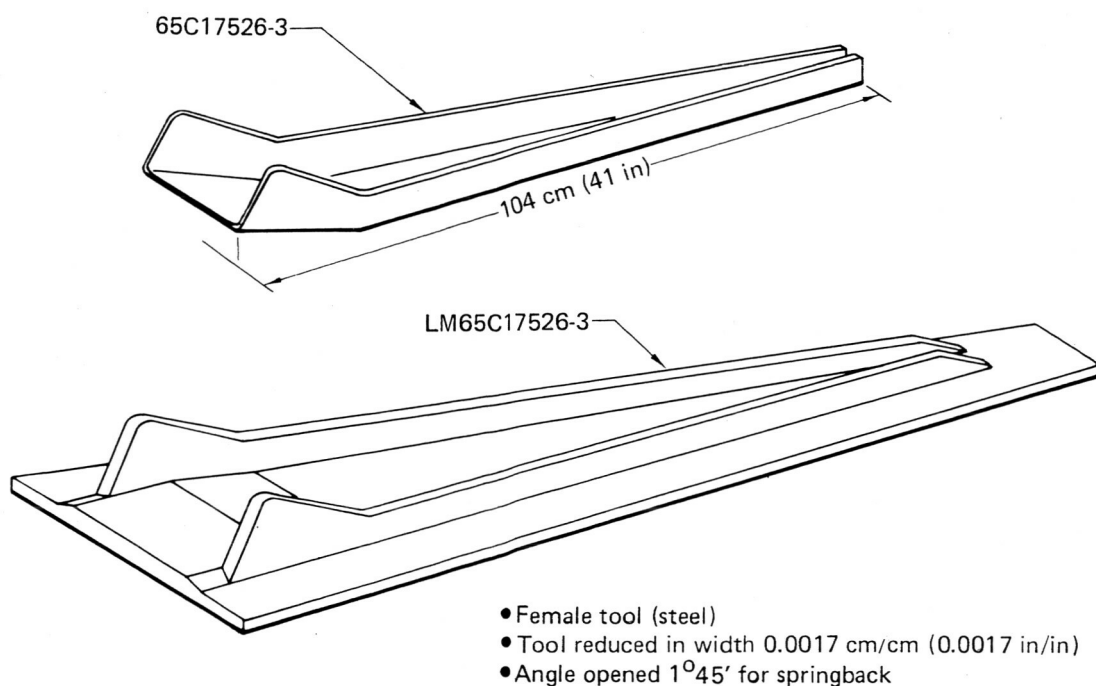
Figure 220. Inboard Closure Rib and Layup Mandrel

Layup Mandrel--A female-configured tool due to core location (figs. 220 and 221).

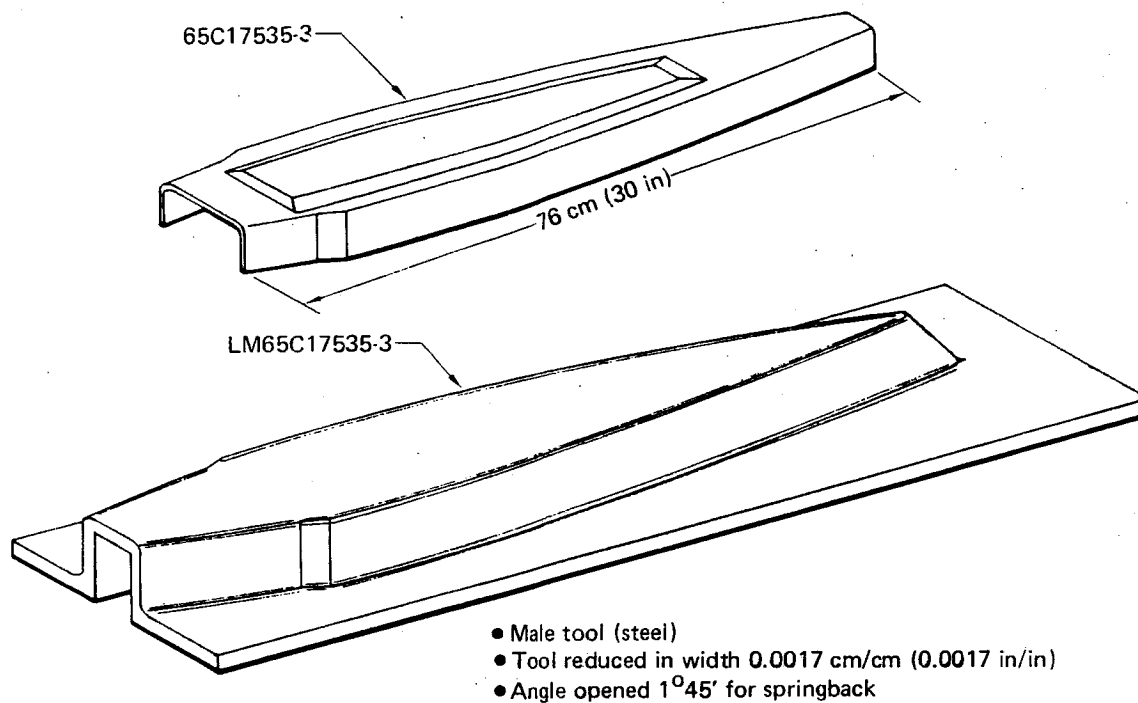
Figure 222. Outboard Closure Rib and Layup Mandrel

Layup Mandrel—This tool is shown in Figure 222.

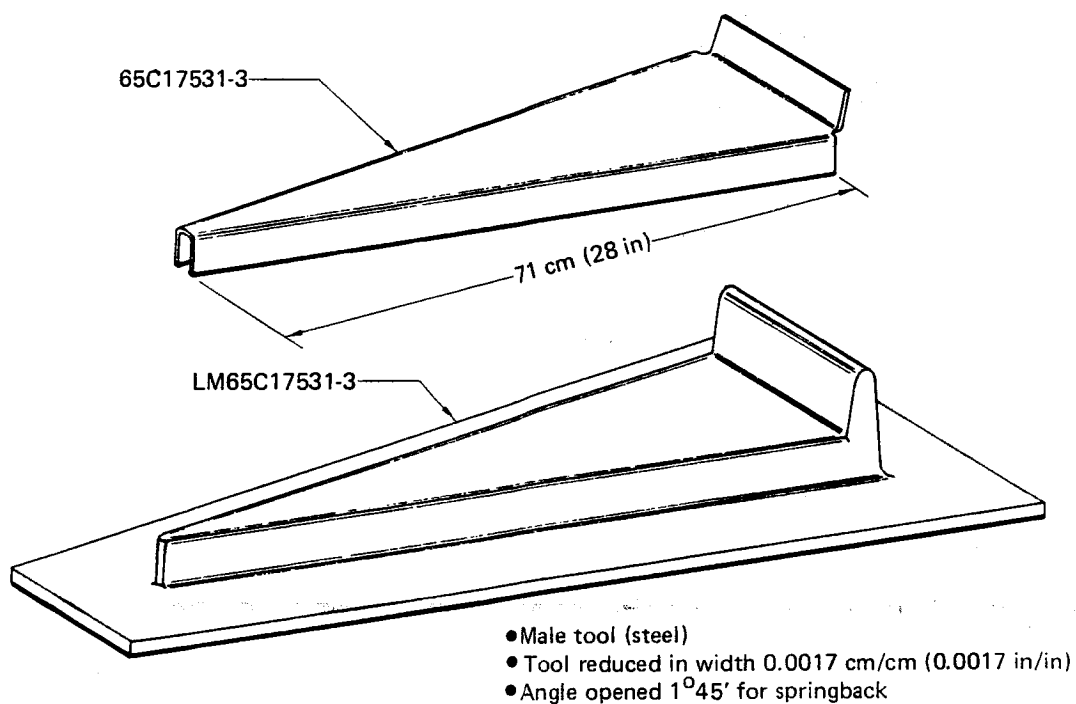
Figure 223. Rib—Station 117.37 and Layup Mandrel

Layup Mandrel—These tools are shown in Figures 223 and 224.
